PHASE I REPORT
NATIONAL DAM SAFETY PROGRAM
TENNESSEE

Name of Dam Construction Products Dam
County Madison
Stream Tributary - Dyer Creek
Date of Inspection February 5, 1981

PHASE I INSPECTION REPORT
NATIONAL DAM SAFETY PROGRAM

PHASE I INSPECTION REPORT
NATIONAL DAM SAFETY PROGRAM
CONSTRUCTION PRODUCTS DAM
MADISON COUNTY, TENNESSEE

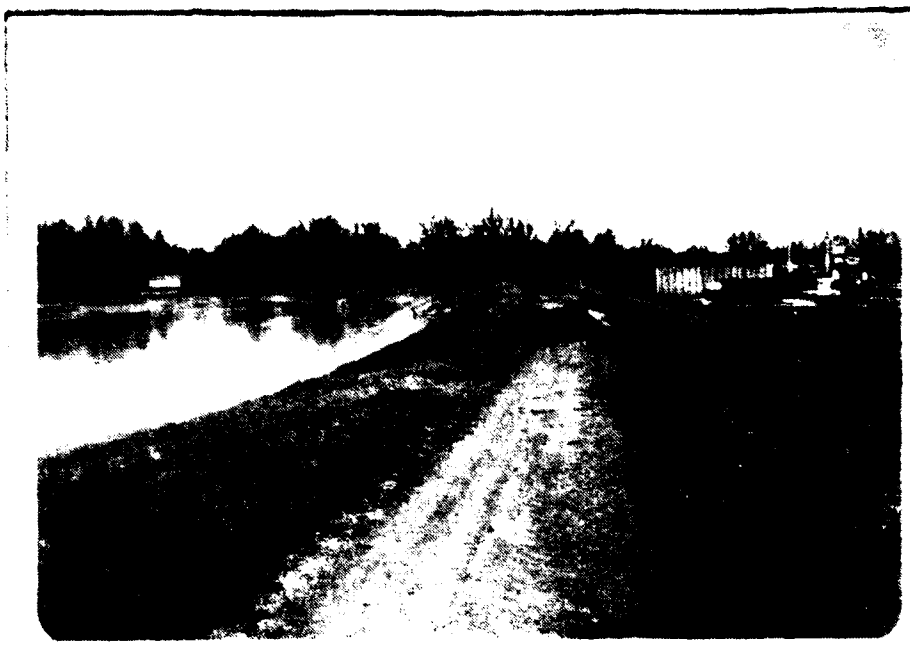
PHOTO NO. 1

- Photo No. 1 - View of the dam and lake.
- Photo No. 2 - View of the downstream slope of the right section of the L-shaped embankment.
- Photo No. 3 - Erosion on the crest of the right portion of the embankment caused by vehicular traffic.

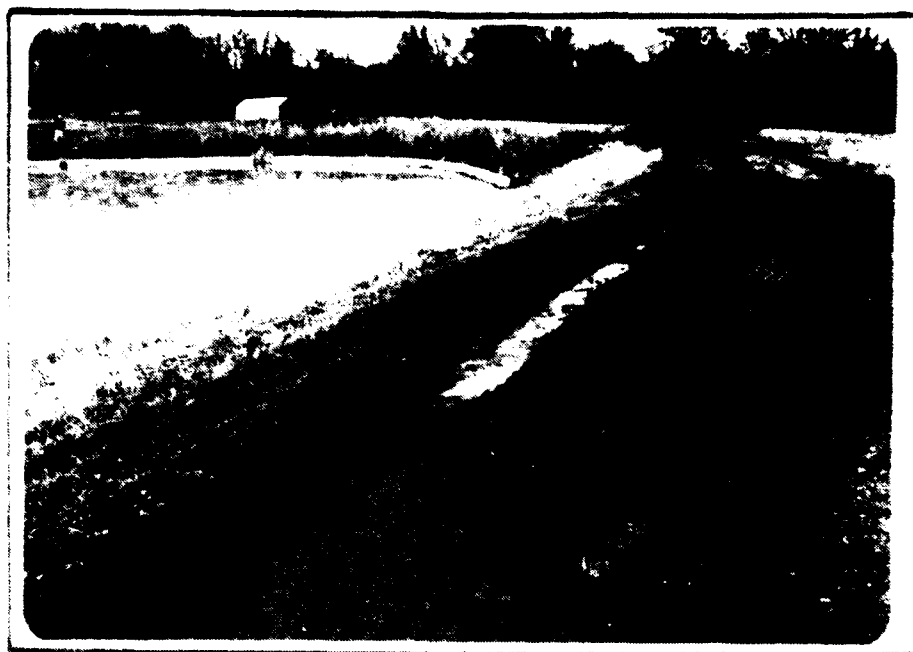
PHOTO NO. 3

The crest of the dam has deep gullies caused by vehicular traffic (photo no. 3). There is no erosion protection except for a small amount of gravel at the south (left) end (photo no. 4).

- 1) Provide additional storage and/or spillway capacity to allow the dam to safely pass the recommended $\frac{1}{4}$ PMF.
- 2) Provide a protective surface on the crest to accommodate vehicular traffic. (An asphalt roadway was observed on 5/4/81.)
- 3) Establish a program for general maintenance and regular inspection.
- 4) An emergency action plan should be established to alert downstream residents in case a major problem develops with the project.

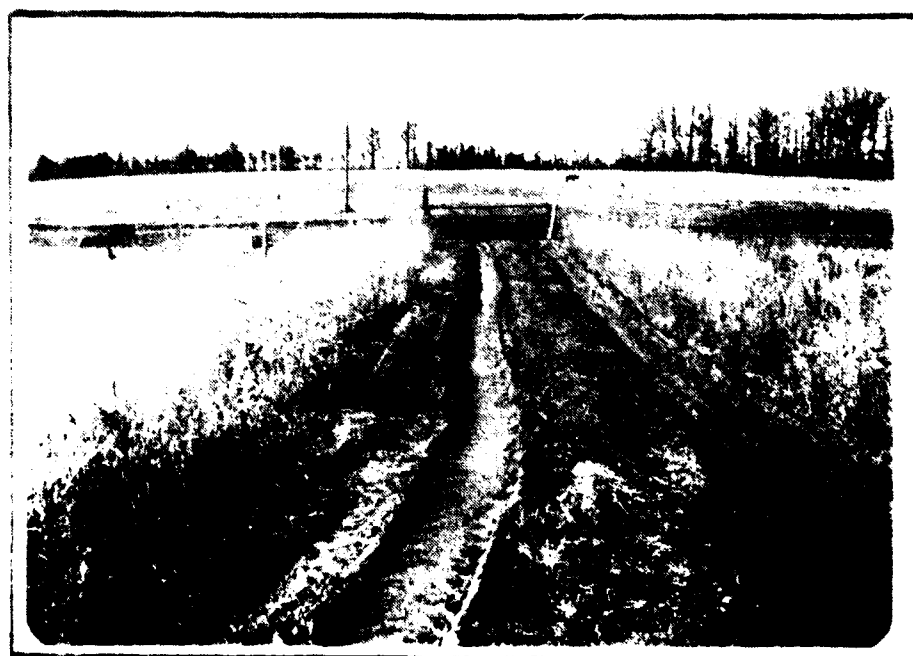
PHOTO NO. 4

- Photo No. 4 - Erosion of the crest at the left end caused by vehicular traffic.
- Photo No. 5 - View of a concrete wave wall along the upstream slope at the left portion of the embankment.

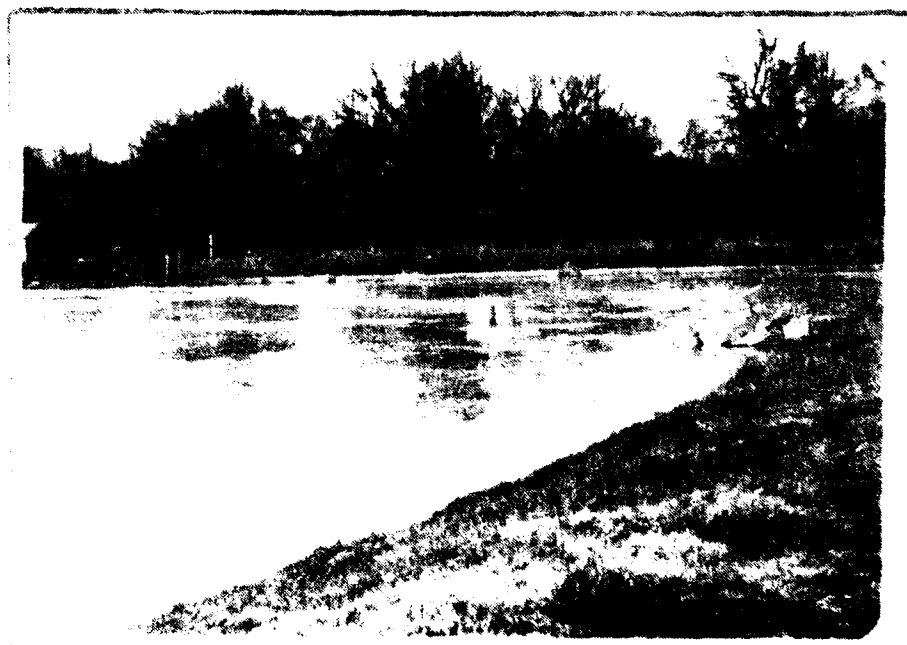
PHOTO NO. 10

2.4.3 Drawdown Facilities - A manually operated slide headgate of unknown size is located at the bottom of the upstream side of the riser. The operating stem is bolted to the riser and extends above the water surface (photo no. 10).

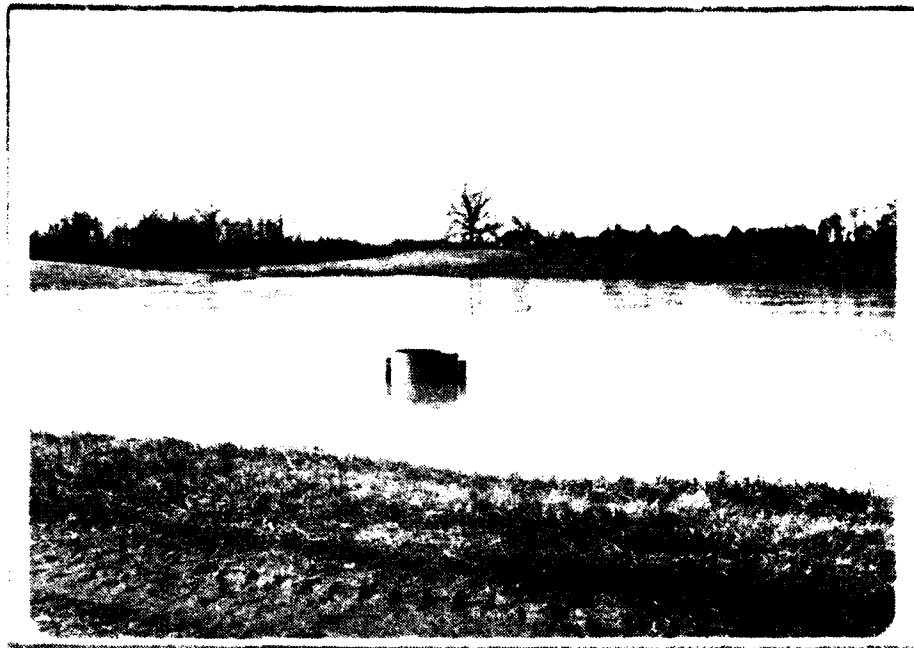
PHOTO NO 11

2.4.2 Principal Spillway - The principal spillway consists of a 36 inch CMP riser enclosed in a 48 inch CMP anti-vortex baffle (photo no. 11). The outlet pipe is a 30 inch CMP (elevation 373.2), approximately 115 feet in length (photo no. 12). The pipe reportedly has anti-seep collars. It empties into a small earthen stilling basin that partially submerges the pipe. The outlet channel runs along the toe of the right embankment section.

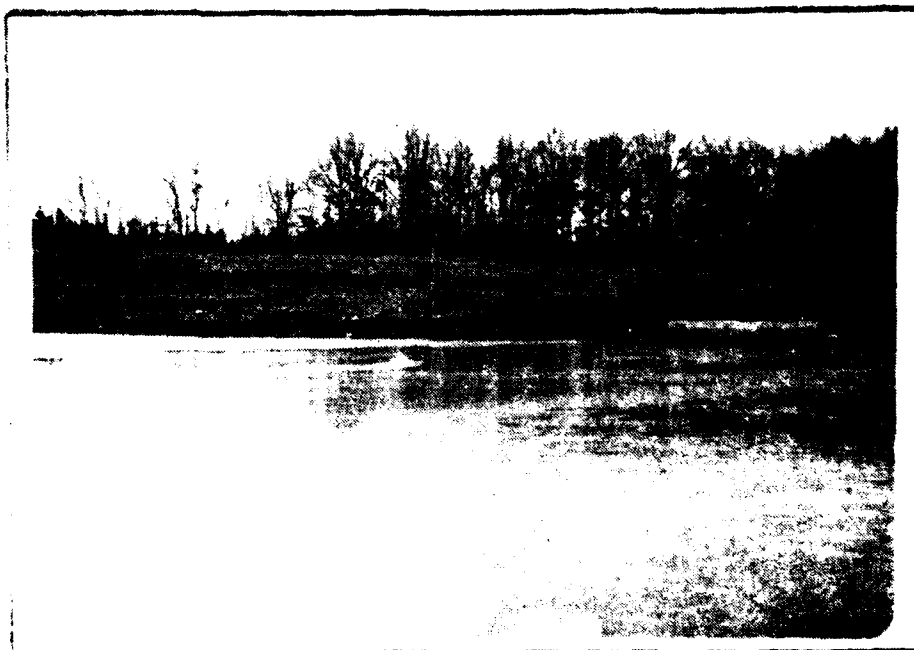
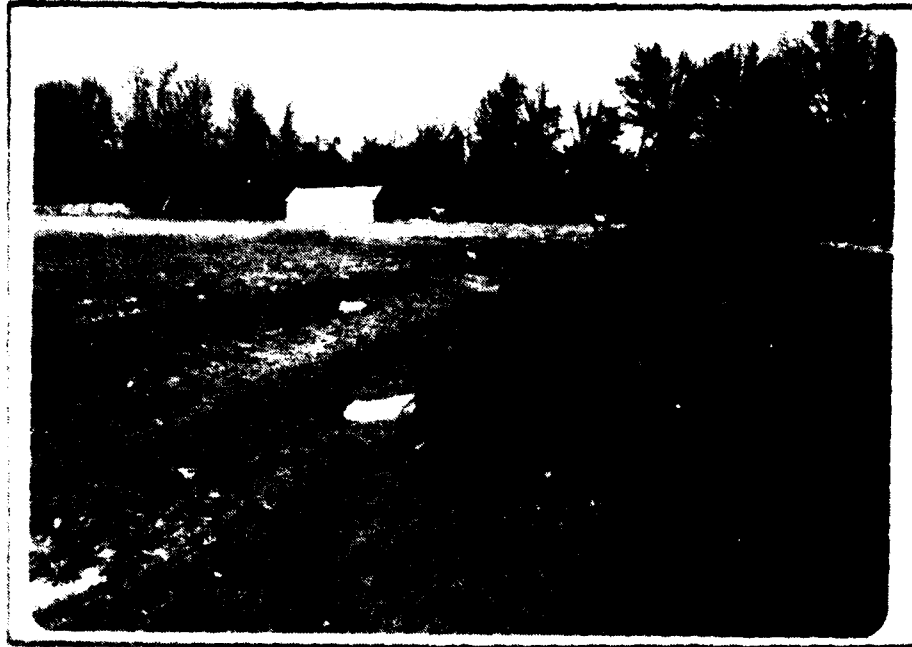
2.4.4 Emergency Spillway - The emergency spillway is an unlined earth channel at the left abutment (elevation 386.4). The channel is very shallow and approximately trapezoidal in shape (Sheet 3 of 5, Appendix B). Downstream of the dam, the channel becomes less defined and enters a wide flat pasture (photo nos. 14, 15, & 16).

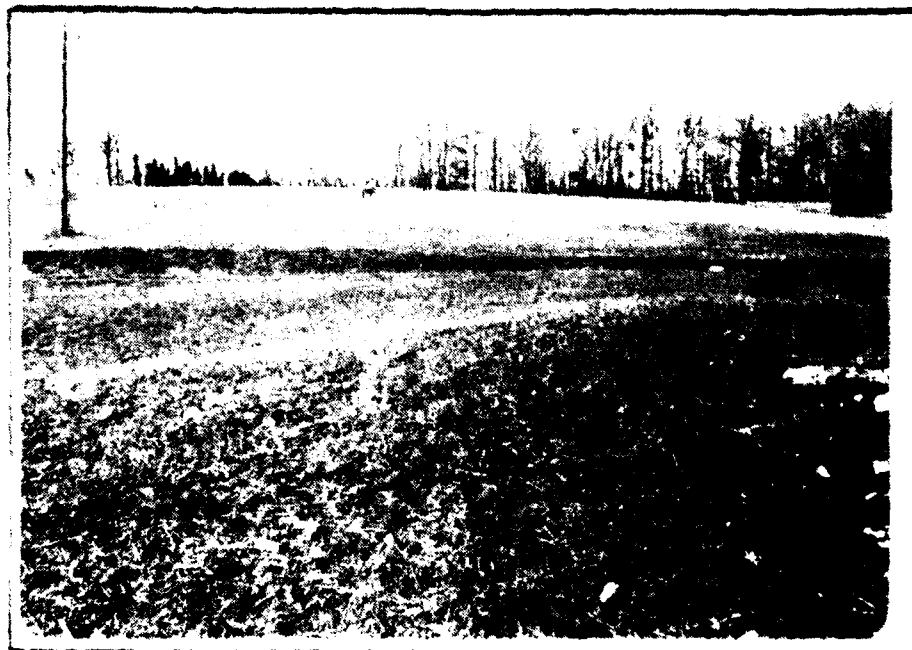
PHOTO NO. 16

- Photo No. 16 - View of the emergency spillway entrance channel.
- Photo No. 17 - View of storage and maintenance facilities located downstream of the dam.

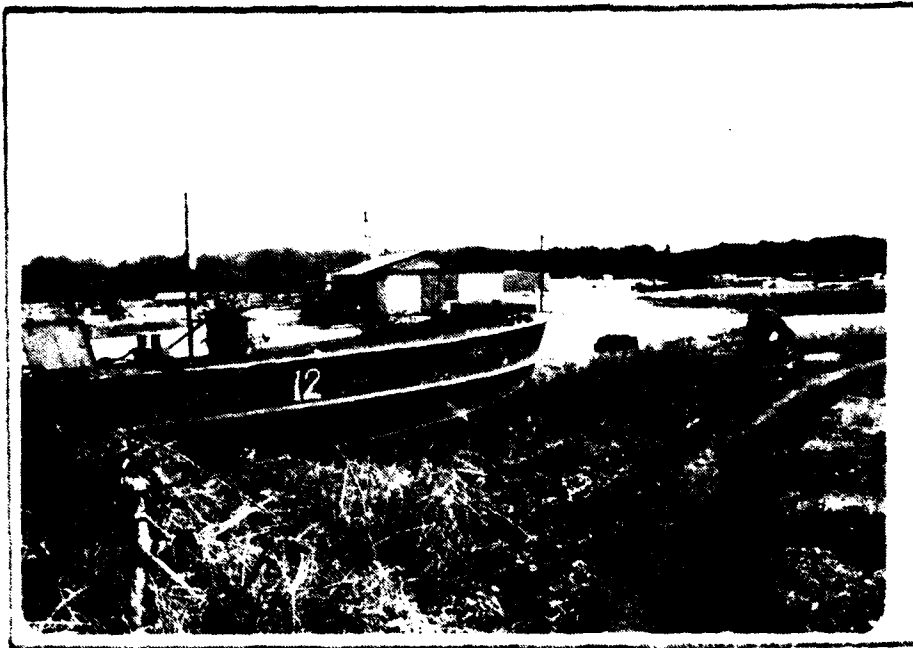
PHOTO NO. 17

The dam is classified in the high hazard potential category due to the downstream presence of several storage, maintenance, and manufacturing buildings owned and operated by Construction Products, Inc. (photo nos. 17 & 18).

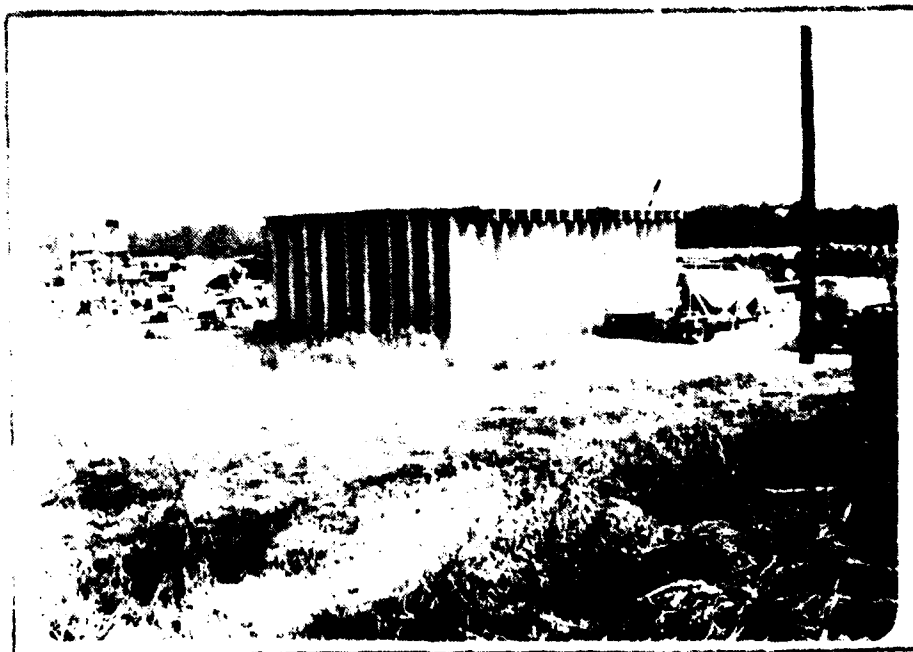
PHOTO NO. 18

- Photo No. 18 - View of plant facilities located directly below the dam.
